# Arlington House, The Robert E. Lee Memorial

## North Dependency Historic Structure Report

2010-0053-P

Report prepared by Charles Fisher, Chad Randl and Kaaren Staveteig

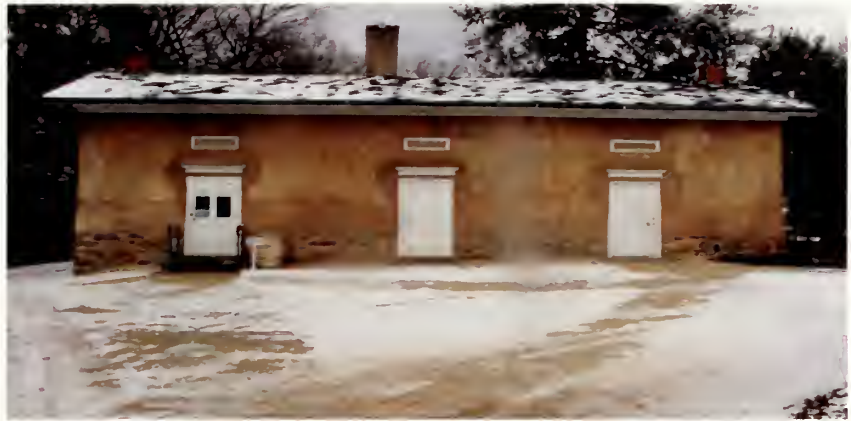
Figure 1. South elevation of the North Dependency, 2003.

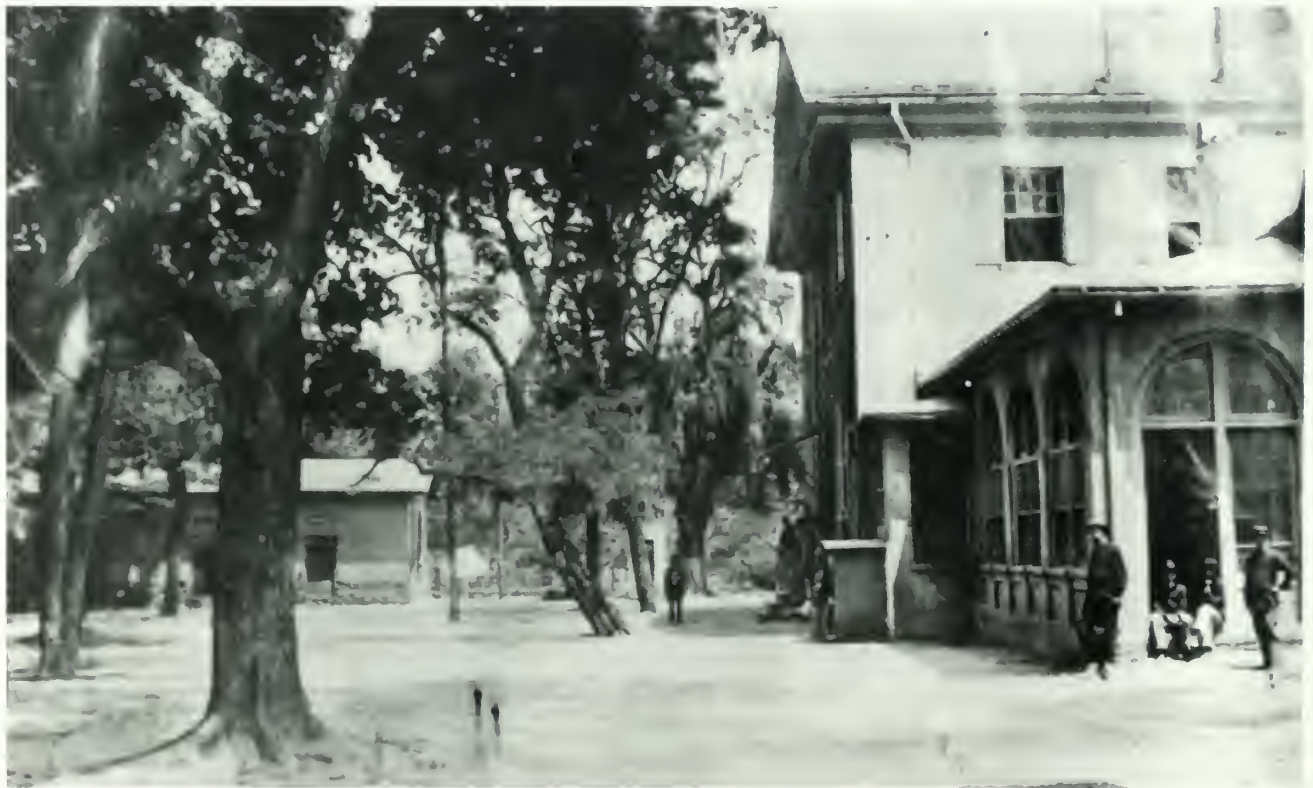
Figure 8. South elevation, 1864 photo by Andrew Russell showing center and east doors of the North Dependency. This image confirms that the door openings were near grade during the Civil War period. Other features seen on this elevation (the rough cast stucco, panel doors, exposed stone foundation, painted panels, and cornices above the door) correspond to the building's current appearance.

Captain Andrew Russell, a colleague of the well-known Civil War photographer Matthew Brady, took a series of photographs at Arlington on June 28-29, 1864. One image showed much of the south and east elevations (Figure 8). While it can not be assumed that the south exterior elevation had remained untouched between the original construction and the time Russell took the photographs, the current physical investigation has confirmed that many of the features, materials, and characteristics seen in the photographs were original to the building's construction.

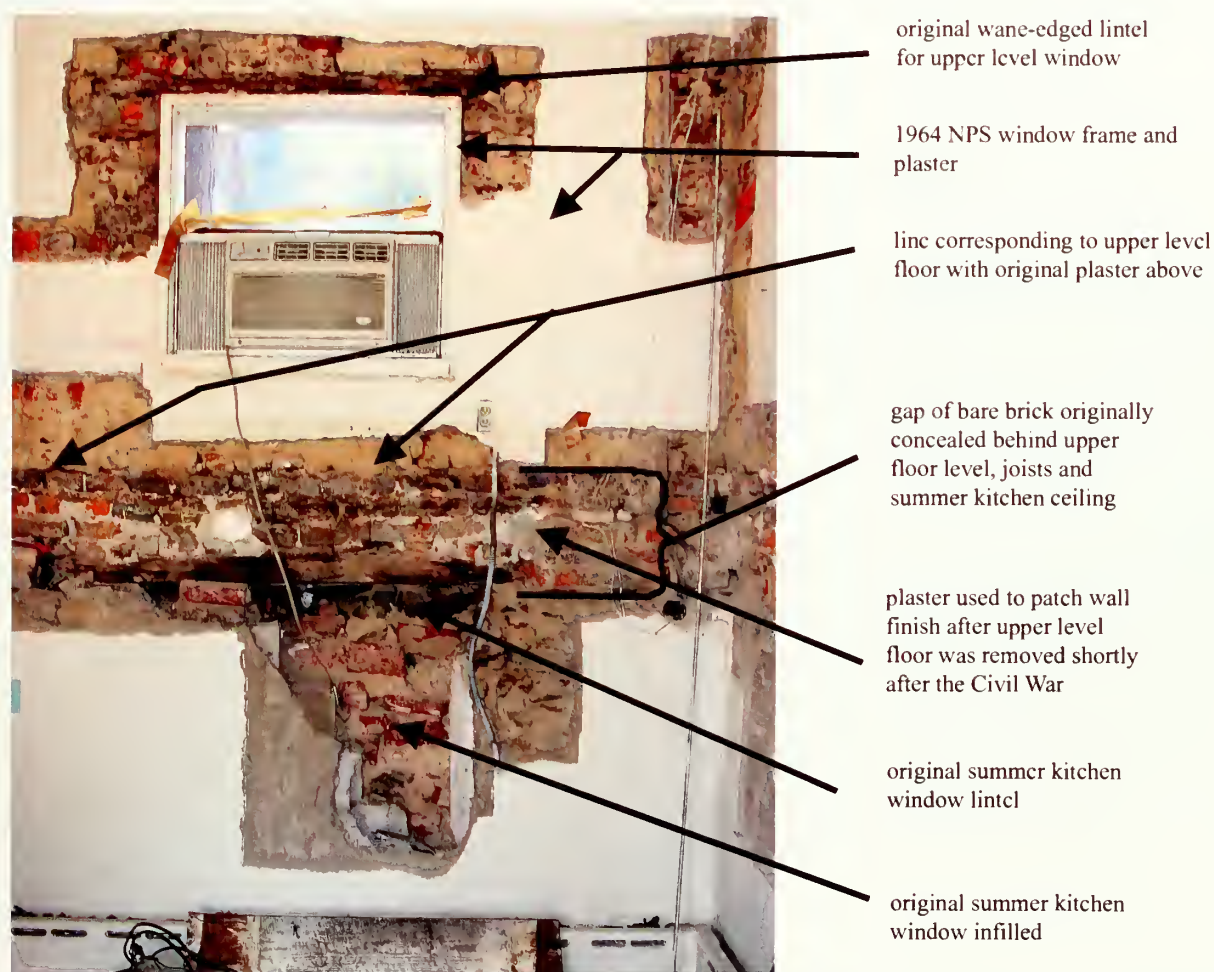
Figure 13. East room, east half of north wall, 2003. Showing evidence of original upper-level floor location and summer kitchen window. Also visible are alterations made when the upper-level floor was removed by the QMC after the Civil War, work done by the QMC in 1929, and changes made in 1964 when the NPS infilled the lower window and converted the room back to a single story space.

Considerable information about the east room's historic configuration as two distinct spaces was revealed beneath the 1964 plaster along the north wall (Figure 13). Here the lower edge of the upper living space is even more clearly defined than on the south wall. Original plaster ends at a relatively smooth line that corresponded with what was probably the upper edge of a baseboard. The position of this line corresponds with the position of the unused baseboard nailing blocks on the south wall. Again, the gap of bare brick below corresponds to an area originally hidden beneath the upper-level floor, joists and summer kitchen ceiling. (This area was patched with plaster shortly after the Civil War when the upper-level was removed from this space.) Further up, original nailing blocks are set within the brick wall further indicating plans for a chair rail molding. As with those found on the east wall, the absence of nail holes indicates that moldings were likely never installed.

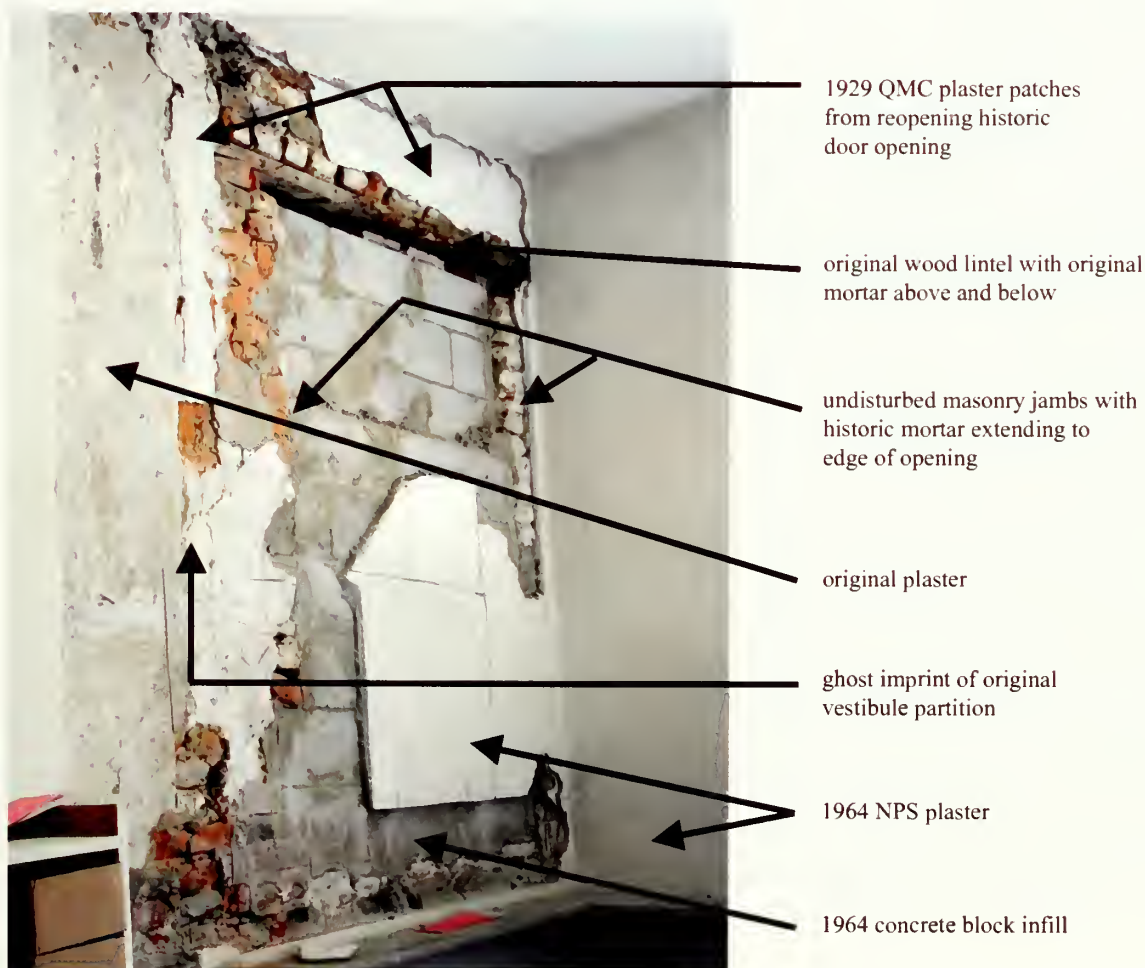
The door openings on the east and west walls near the exterior entrance are original to the building (Figure 18). These doorways provided access to the upper-levels of the east and west rooms. It is likely that the openings were reached from the center room doorway via wood ships ladders, as there was limited space (and a lack of physical evidence) for a stairway. Historic mortar and brick extending to smooth, undisturbed door edges indicates that the openings were created as part of the building's construction. The east door lintel which is bedded in original mortar further confirms this. Though the oak lintel has been part of the wall structure since the original construction, ghosts of whitewash finish on the concealed top surface suggest that it was reused from an earlier structure.

Figure 18. Center room, south corner of east wall, 2003. Showing the original doorway to the east room upper-level. This opening and the corresponding opening on the west wall were filled in by the QMC after the Civil War, when the adjacent rooms were converted to a single story space. The QMC reestablished the openings in 1929 as part of their restoration. The National Park Service closed them up again in 1964 when they reverted to single story spaces in the end rooms.

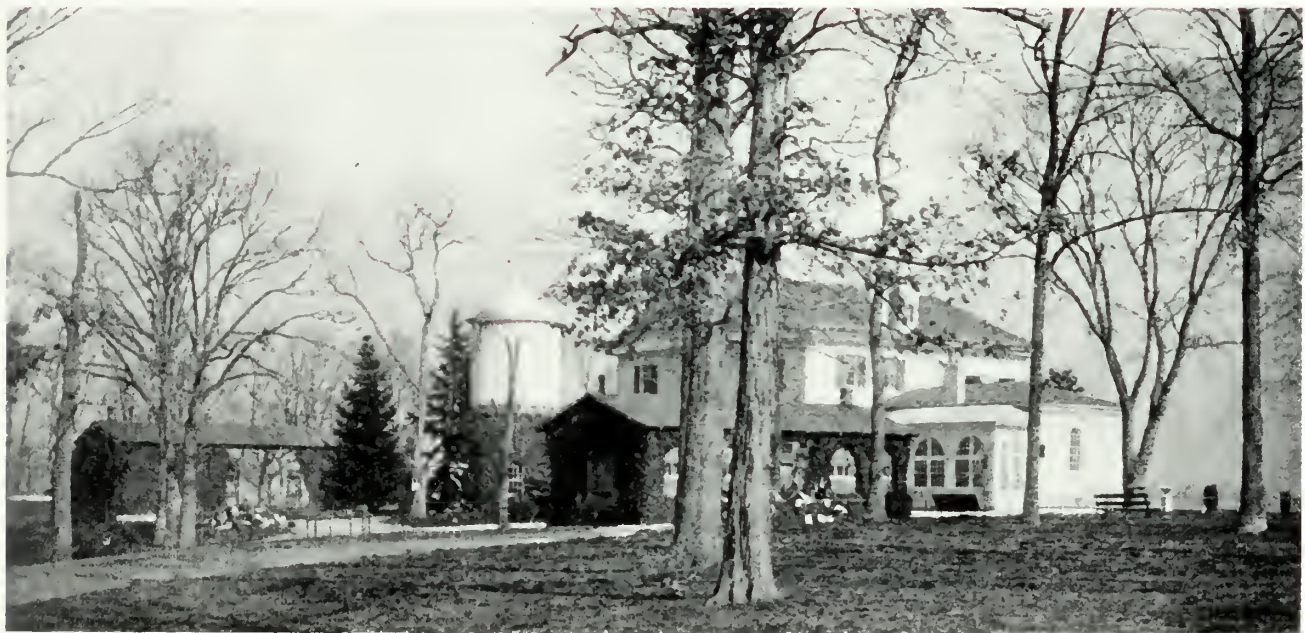
There is little information about the condition and work done on the North Dependency during this period. An 1897 photograph of the south elevation of the building shows much of it covered in vegetation (Figure 24). Doors that are different from those seen in the Uncle Joe and Andrew Russell photographs are visible. These doors appear dark in color and have a four-light window in the upper half.

Figure 24. Arlington in 1897. Note the extensive vine coverage. Replacement doors have glazed four-light panels in the upper half.

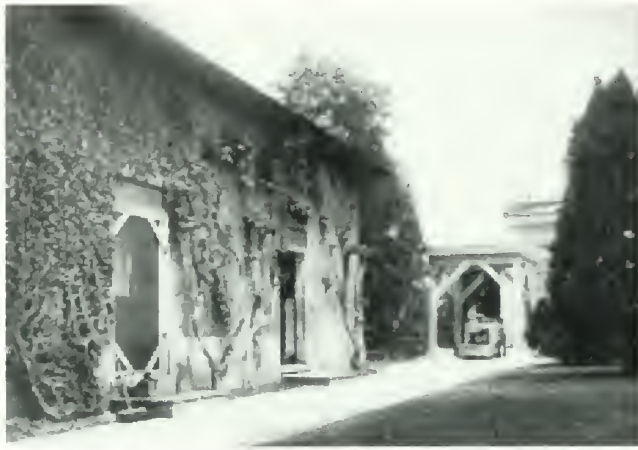
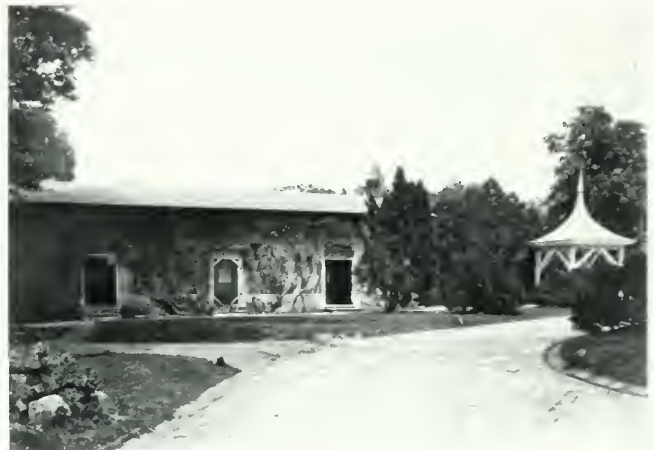
Photographs from around 1900 provide a better view of the doors (Figures 25 and 26). The images also show that the masonry foundation had been parged and that the projecting cornices above the doors had been removed and replaced with flat panels. (The foundation probably received the coat of stucco at the time the interior was converted to a single story space—the finish concealing infilled lower-level windows on the north elevation.) The flat panels, doors, soffit, and outriggers all appear darker than the door jambs are lighter. A screen door is installed on the center room, in keeping with its use as a residence. All three doors on the south elevation were entered after one step (a platform) above the grade level. With hinges on the west side door jamb, their swing was reversed from Civil War-era. From open doors on the east and west rooms, it is clear that the removal of the upper-level and raising of the floor to grade had already occurred by the time these photographs were taken. In one image the shoulder in the east room is clearly visible, in another image one of the north elevation upper windows can be seen in the back of the west room. The corresponding lower windows are not visible since they were filled in.

Figures 25 and 26. Photographs of south elevation, circa 1900. The photos show the replacement doors and the foundation with its stucco finish (in the 1860s the foundation was exposed masonry). More importantly, the open door to the east room reveals an exposed shoulder where the original upper-level floor joists once sat. This is consistent with the space being used after the Civil War as a single-level open room with a floor at-grade.

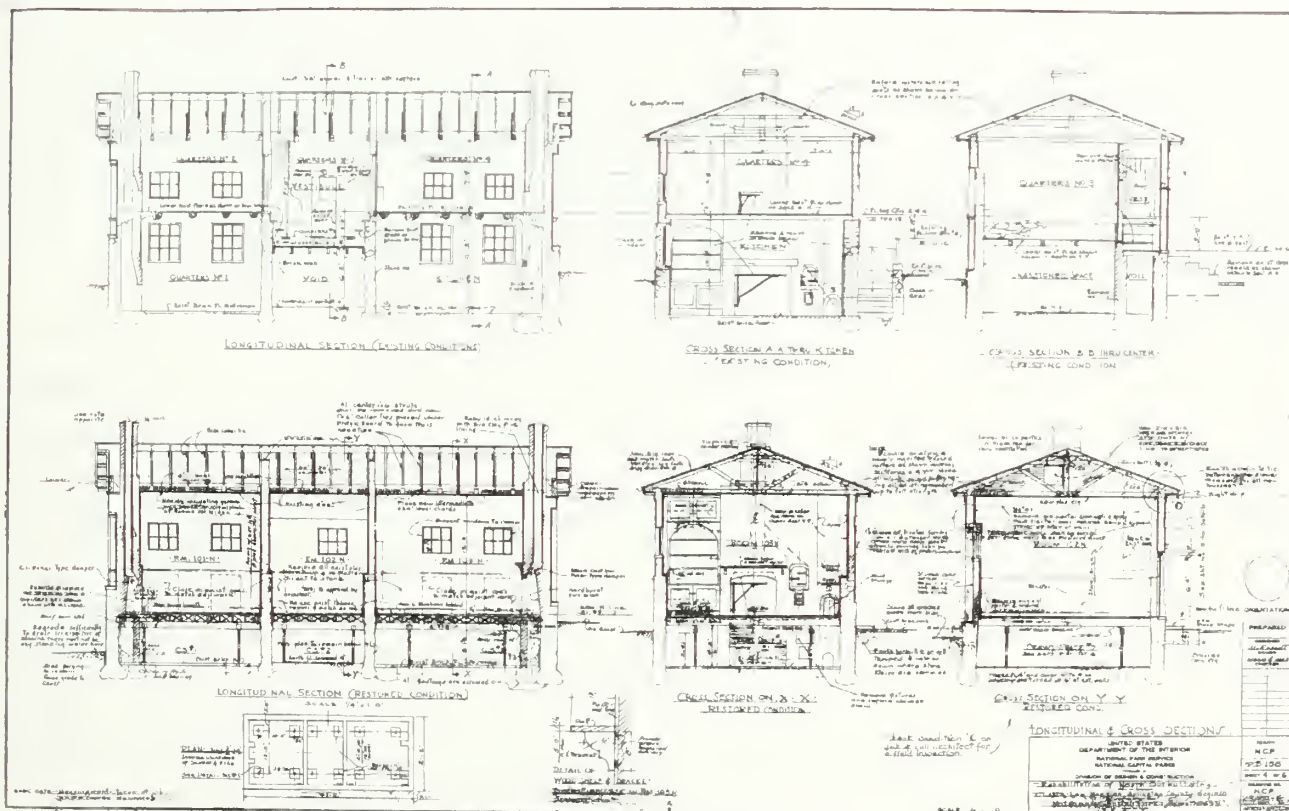
Figure 37. 1960 section drawing depicting the NPS intention to restore the North Dependency interiors to single story spaces with a summer kitchen, living quarters, and entrances on grade. The existing plans are shown above and the proposed restoration plans are below.

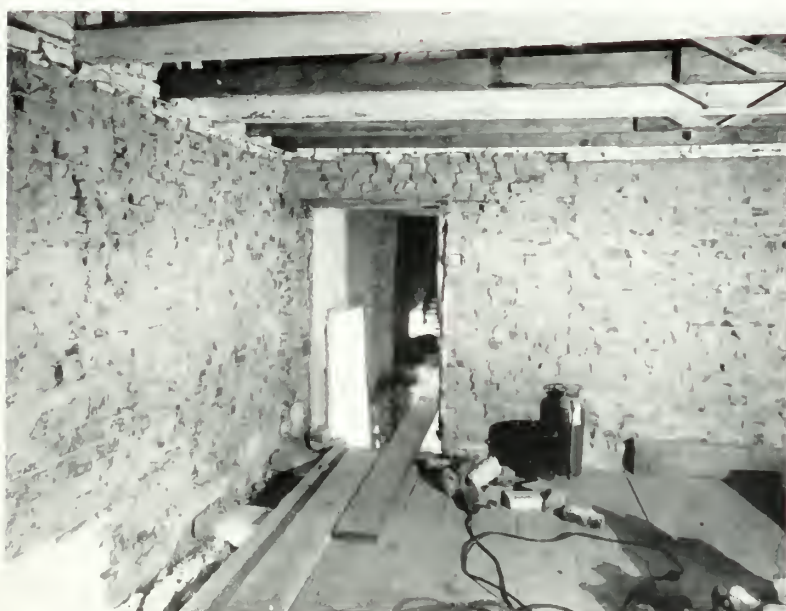
Figure 38. Looking west from east room upper-level into center room through the doorway, 1964 photo showing NPS removal of QMC upper-level floors in progress, and additional joists (those unpainted) inserted between the older joists.

Rowe’s photographs from July 27, 1964, show work underway in the interior of the North Dependency (Figures 38 and 39). Plaster had been removed from the wall surfaces in the upper-level rooms. Strips from 2' - 5' wide, where the plaster had been removed exposing the masonry walls were visible along the lower-level walls. This was clearly a result of the NPS historians search for evidence of an original floor location near grade. Areas near the fireplace and doorways also had significant areas where plaster had been removed in the search for clues to the historic configuration of these spaces. The photographs show that the east and west doorways at-grade on the south elevation had been opened up, but that the center room door had not yet been lowered to its 1860 position (after having been raised and the cornice removed as part of the 1929 QMC restoration). At the time Rowe took his photographs, the upper-level interior doors into the center room were still opened up and the oak sill is visible above the east door. The new, unpainted joists and braces added to the roof structure the previous week are clearly visible next to the older whitewashed joists.

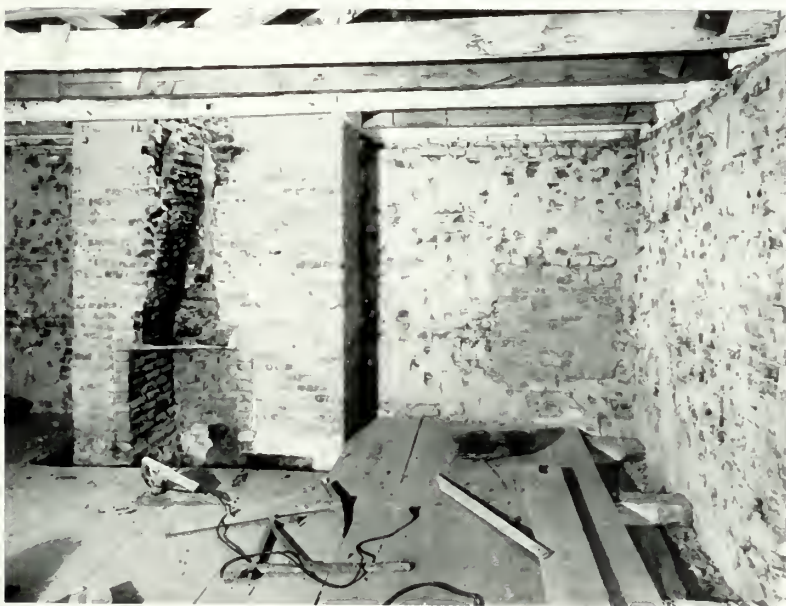
Figure 39. East room upper-level looking east, 1964, showing NPS investigation of fireplace and removal of upper-level floor in progress.

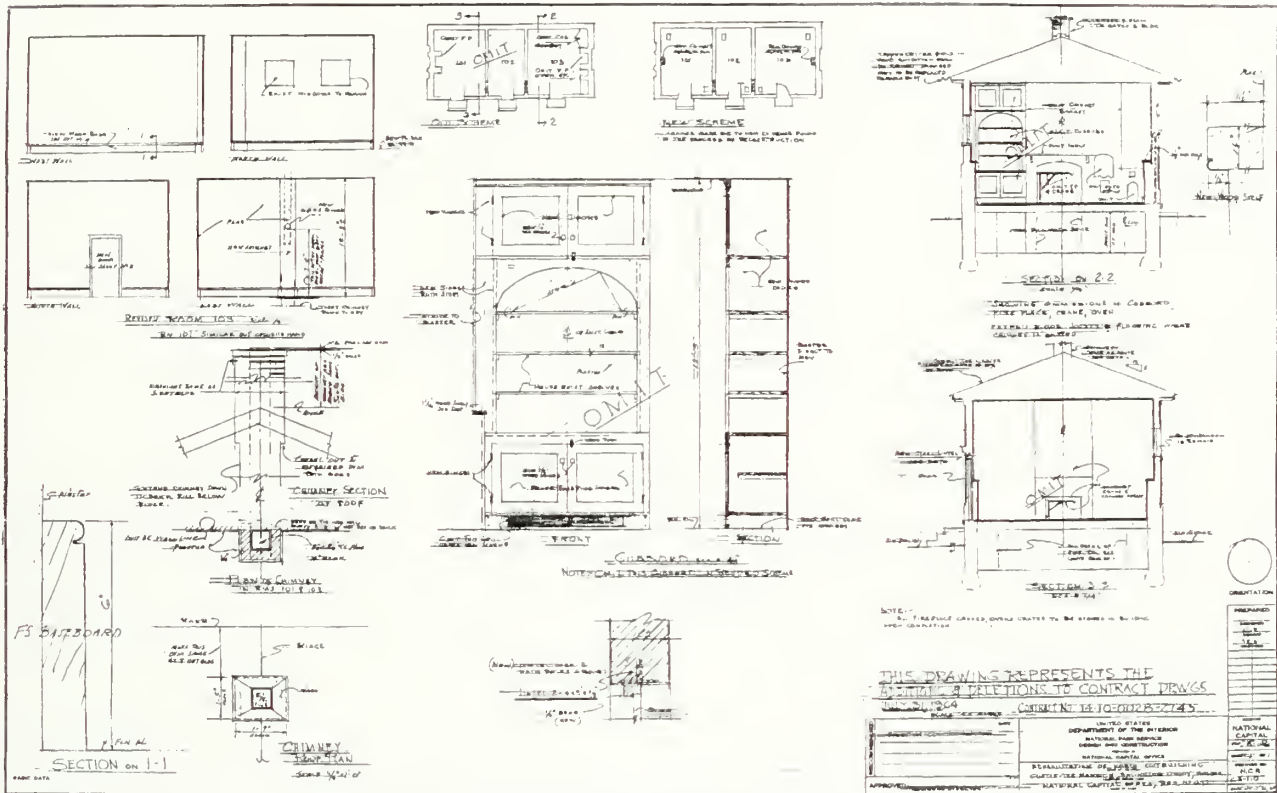
Figure 40. 1964 drawings showing NPS plans for a grade-level summer kitchen omitted.

On July 31, 1964, the National Capital Office of Design and Construction, issued a new series of drawings with “omit” written across plans for the at-grade fireplace, oven, and cabinet (Figure 40). A note stated that “change made due to new evidence found in the process of reconstruction.” The rest of that week as well as the first two weeks in August were spent removing the old chimney above the newly planned floor at-grade, filling in the fireplace openings, and installing the new floor levels in the center and west rooms. Work was also undertaken on the south elevation, including installing door frames, filling in the basement entrances, removing stone steps down to the basement, filling the stairwell with rubble and laying concrete over top, and installing the stone steps up to each doorway. The area in front of the south entrances was then graded and the stonemason completed work around the new steps.

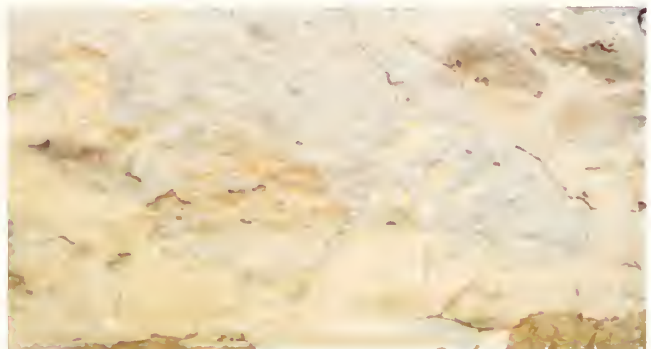
Finish analysis identified early paint coatings on the stone foundation on the north elevation, at the northwest end and on the south elevation (Figure 4). This treatment may have been applied in the years immediately following construction, concurrent with the exterior painted brick on the upper walls. Due to the fragmentary nature of the paint, a detail analysis may not be conclusive as to its date of origin. By the 1850s, the stone foundation was exposed. A drawing by Lee's daughter and early photographs from 1864 through c.1900 show the stone coursing and a distinctive variation of color from stone to stone. However, at some point in the early twentieth century, photographs show a parged coating of lime/cement mixture, giving the lower walls a smooth, more regular appearance. During the QMC restoration, the parging was removed.

Figure 4. Numerous areas of paint on the stone foundation may be evidence of an early coatings treatment.

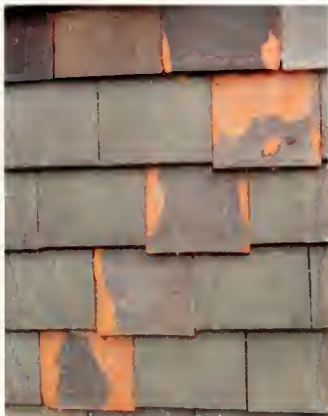
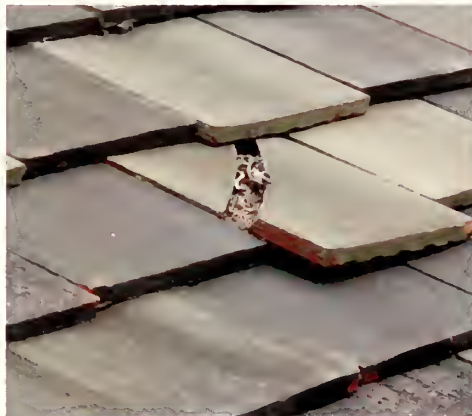
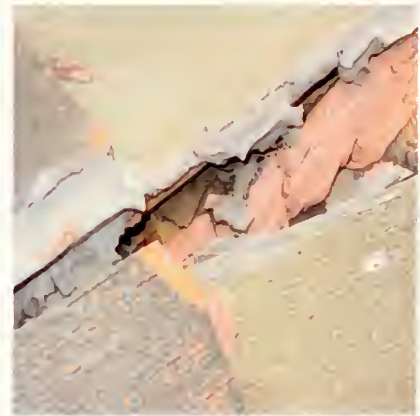
Figure 7: Delamination, chipping, crazing, and structural failure of tile shingles

Deficiencies: Delamination, chipping, crazing, and structural failure of tile shingles is widespread

(Figure 6); approximately 1/3 exhibit delamination. Fallen branches from a tree on the north elevation have contributed to the failure. Five to ten percent are cracked, with some retaining vegetation. By trapping moisture and preventing the roof from adequately breathing, felt roofing paper may be adversely affecting the wood sheathing beneath. Premature failure can be seen in the delamination.

**Recommendations:** Remove the clay tile roofing. Add wood nailing strips on top of existing sheathing to allow for appropriate ventilation. In the early nineteenth century, wood shingles were typically applied over skip lath with strips measuring from 1 1/8" x 2 1/4", fastened to each rafter they crossed with a cut or handmade nail. A high quality short lap wood shingle measuring 5" to 6" wide in a length varying from 18" to 20" should be used. The shingle butts wood shingles should be about 1/2" thick. The exposure of the shingles should be 5 1/2" to 6" on the south exposure while the north slope could be from 5" to 5 1/2". Install copper flashing under capping shingles at ridge. A comb at the roof ridge should extend from the north slope out over the south slope as much as 4"-6" (*see Appendix G*). Solder flashing rather than caulk should be used at the chimneys.

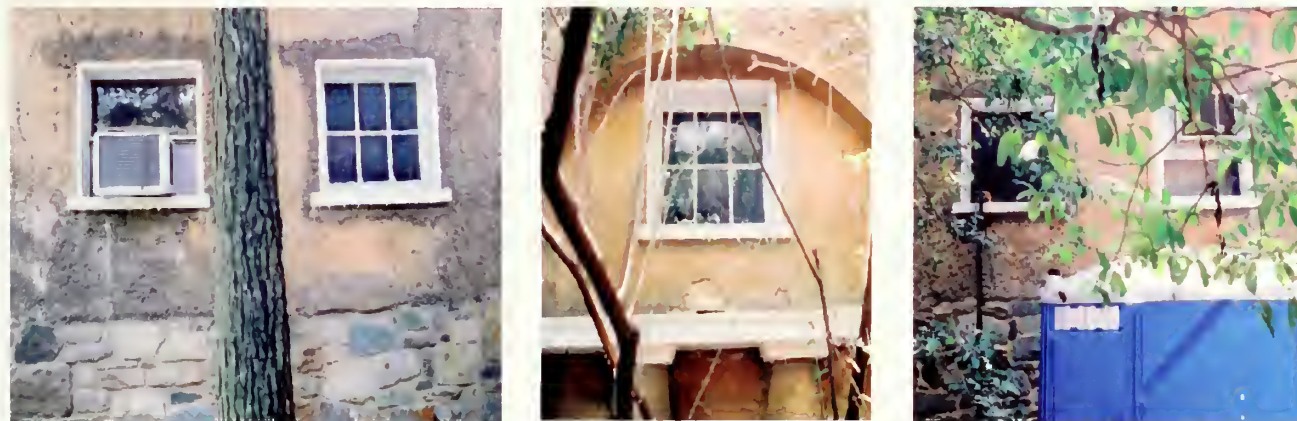
Figure 12. Left-windows opening into the east room (ND5 and ND6); center-window opening into center room (ND9); right-windows opening into the west room (ND10 and ND 11).

**Deficiencies:** The extant window jambs and sash are generally in good condition. The relationship of the window frames to the rough east on the exterior vary from window to window. A slight overlap of the stucco over the wood frame is appropriate. Most if not all the sills have been altered or replaced. New ones lack a drip edge.

**Recommendations:** All existing window frames should be removed, marked, and stored in the Park's collection. The rough cast should be removed around the opening and reapplied with a slight overlap on the wood frame. All window sills need drip edges. With the possible exception of the center room window, the current sash and frame construction is too light for the 1850s. New six-light sash for the upper-level with top butt hinges to project inward, should be milled. Jambs should be constructed of cypress and sills of walnut. The four lower-level window openings should be re-opened and filled with a six-over-three hung window with a fixed upper sash and an operable lower sash appropriate for the 1860 time period. See *Appendix F: Supplemental Drawings*.

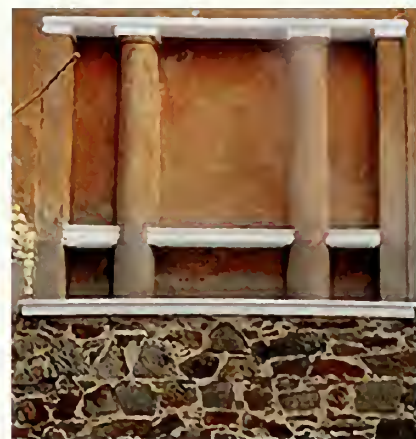
Figure 20. West elevation, ponding water on horizontal trim surface.

**Deficiencies:** The fascia board, replaced by the National Park Service in the 1960s, is deteriorated (Figure 19). Depressions on the flat, horizontal trim surfaces directly below the attic vent within the rectilinear niche allow water to pool precipitating deterioration (Figure 20). All eave modillions on this elevation are replacements from the 1960s when the number was increased from 5 to 8. None are structural in function.

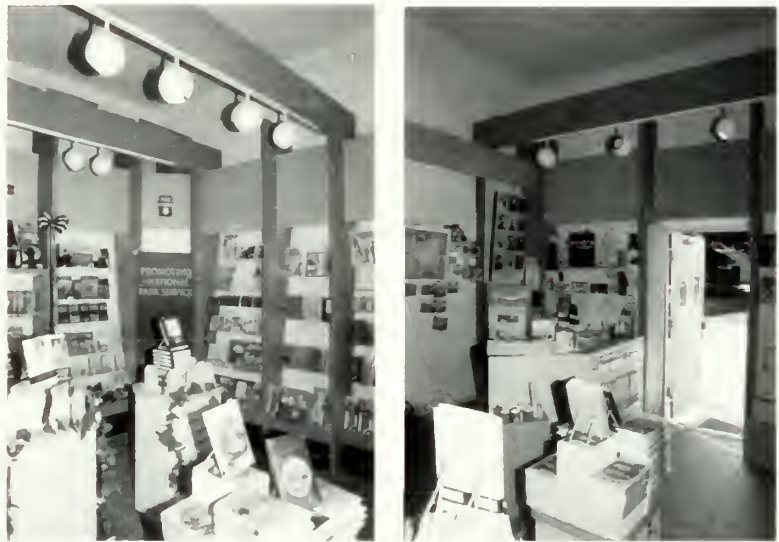
The interior space of the west room measures 18'-6" x 14'-6" with a ceiling height of 12'-3". The ceiling and four walls are whitewashed gypsum board (Figure 33). NPS drawings show the same

floating floor system as installed in the east room in the 1960s, consisting of twelve 4"x 12" joists set 32" o.c., running from east to west with 2"x 4" cross bridging running the center line of the room. The bottom of the floor joists are 4'-3" above the brick floor of the crawl space (at grade) and are supported by four steel posts set into concrete pads. Floor boards, 1 1/2" thick, originally used by the QMC, were reused to surface this floor above the plywood subfloor. A commercial floor tile has been applied to the wood planked surface. The wood hatch opening into the crawl space is 2'-6" x 2'-4" and is located in the southeast corner of the room. The center of the door is covered with a metal grill to allow for ventilation into the crawl space when the door is closed. The physical investigation of this space has been precluded by the fitout of the concessionaire.

Figure 33. West room with book store concessionaire.

Deficiencies: unknown.

Recommendations: The thorough physical investigation should be undertaken to determine the condition of the walls, ceiling and floor before a work program is undertaken.

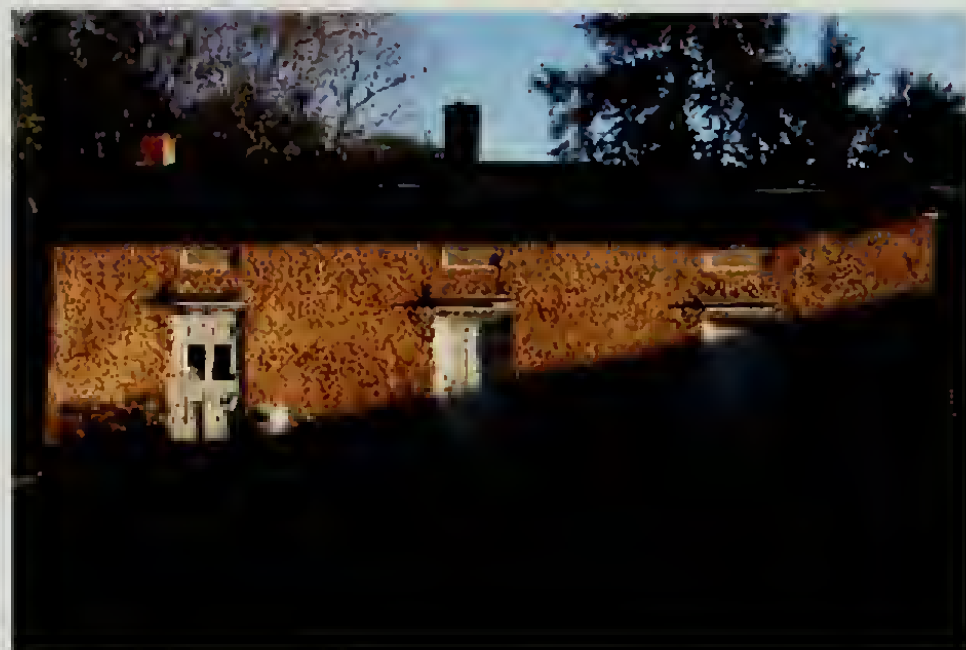
North Dependency, South Elevation

The north dependency is the older of the two structures, as revealed by the investigation of the exterior architectural details and the chronology of finishes. The south, north and east elevations were initially finished with a pebble-dash stucco and painted white. The west elevation was treated as a minor feature; the brickwork was left exposed and washed with the same color as applied to the stuccoed elevations. At a later date, possibly when the south dependency was constructed, the west elevation was stuccoed with a smooth, natural cement stucco.

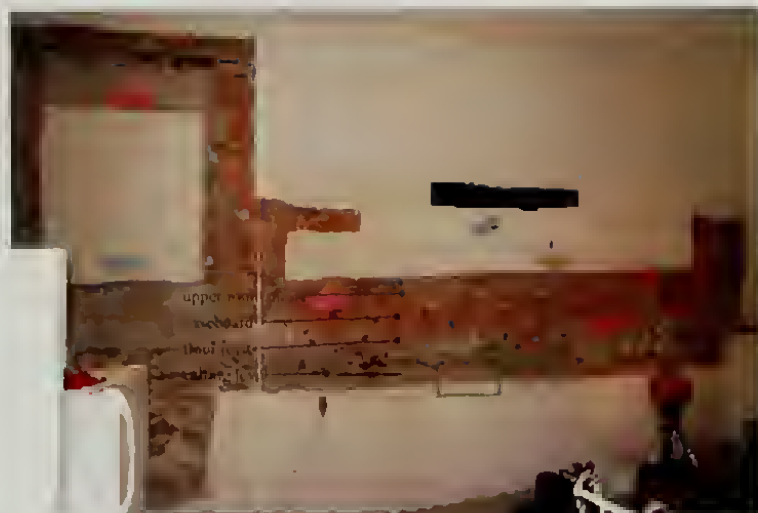
Top of lower room's west wall and the finish level of the plaster ceiling

North Dependency, East Room: The location of the lower kitchen's ceiling is preserved as a line of plaster and finishes on the west elevation.

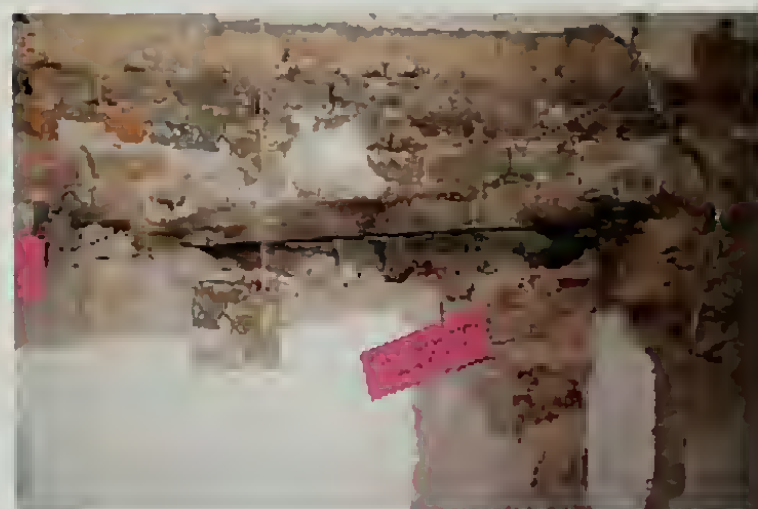
Finish ceiling level in lower room. Note that the ceiling location is indicated by an accumulation of fibers and debris that may date to the early occupancy of the dependency.

North Dependency, East Room: The location of the lower kitchen's ceiling is preserved as a line of plaster and debris on the north elevation, east window.

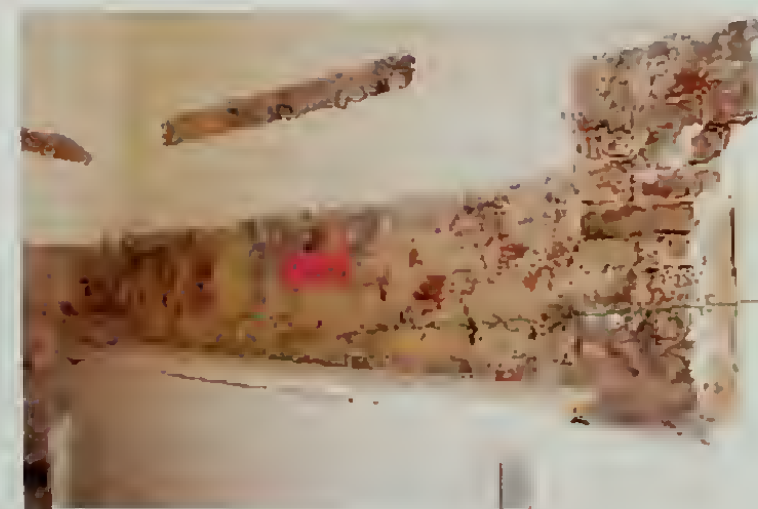
Finish floor level in upper room. Note that there was no baseboard in this location and that the wall finishes extended down to the floor. The last finish applied to this surface was a distemper rose color.

North Dependency, East Room: The location of the upper room's floor level is preserved as a line of plaster and finishes on the south elevation.

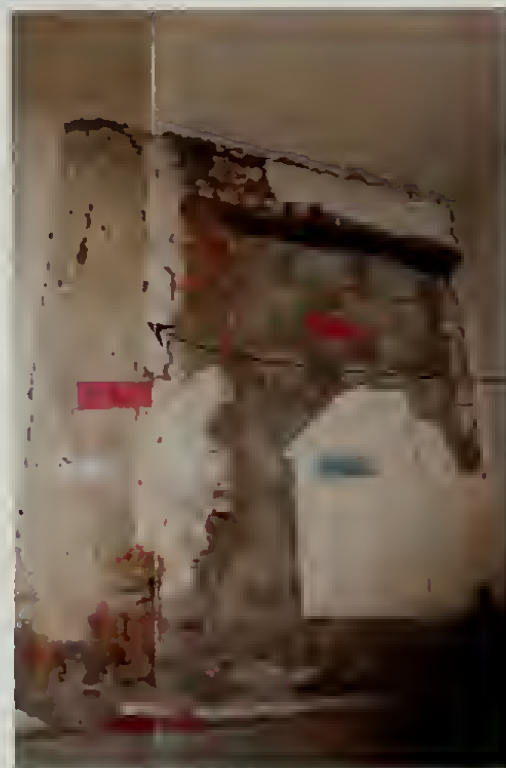
Plank wall location. The wall was installed before the plaster was applied to the walls, and later removed. The patching plaster appears to be a lime-sand mix with a lime wash finish.

North Dependency, Center Room: The location of a plank wall is indicated by a one-inch wide vertical patch in the plaster on the east elevation adjacent to the door. The door opening is original, as indicated by the coursing of the masonry.

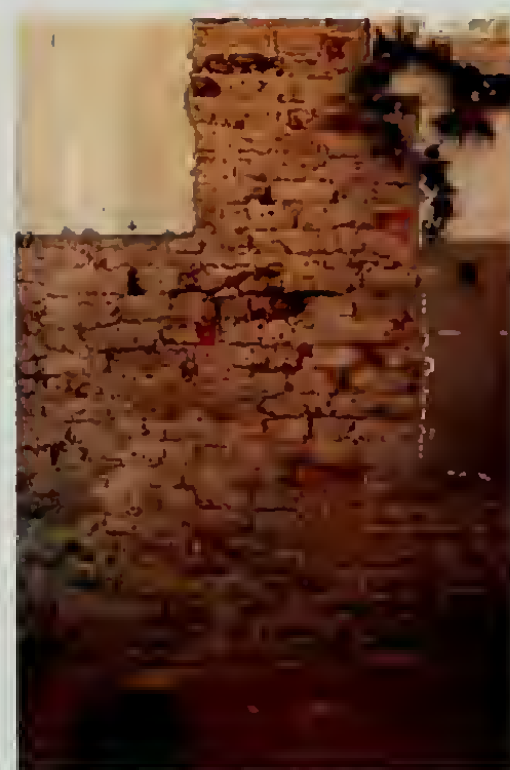
North Dependency, Center Room: This micrograph is of a single remnant of the plaster finishes found on the north elevation. There distemper layers survive; a white wash, a light yellow, and the same medium yellow as found in the east room.

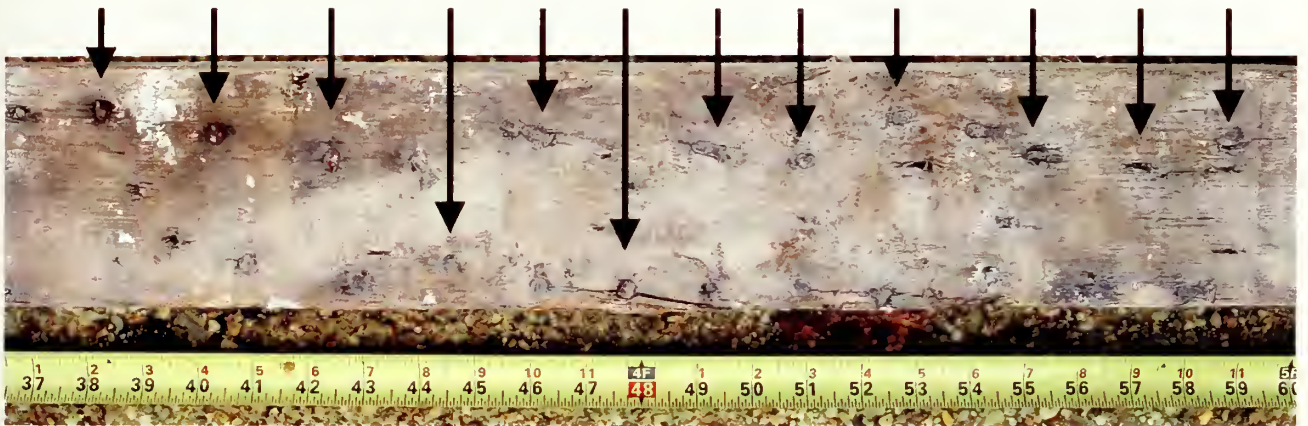
**G**

tightening hole

lath added when joist  
was reused as lintel

original floorboard  
nail holes

lath nails, nail holes and staining that correspond to the original position of the wood lath

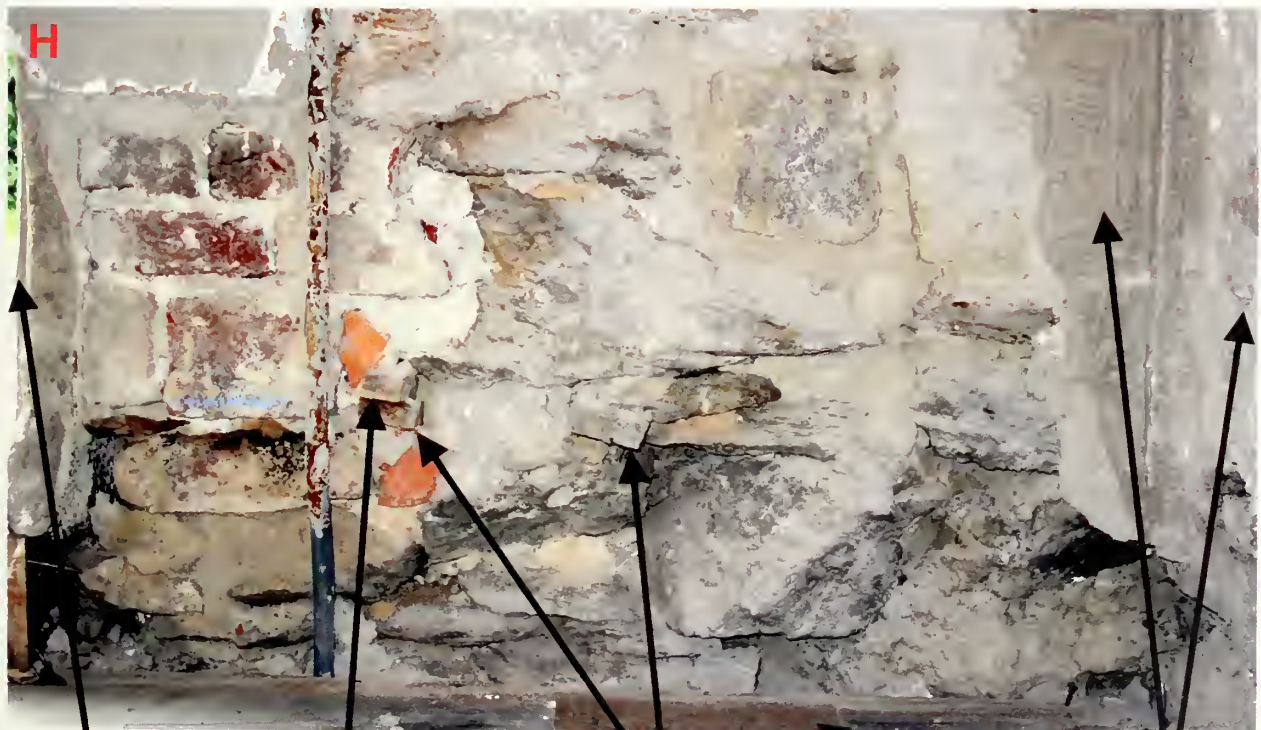
**H**

doorway to  
courtyard

yellow-gold  
paint on portions of  
nailing block

current floor level

1964 NPS plaster

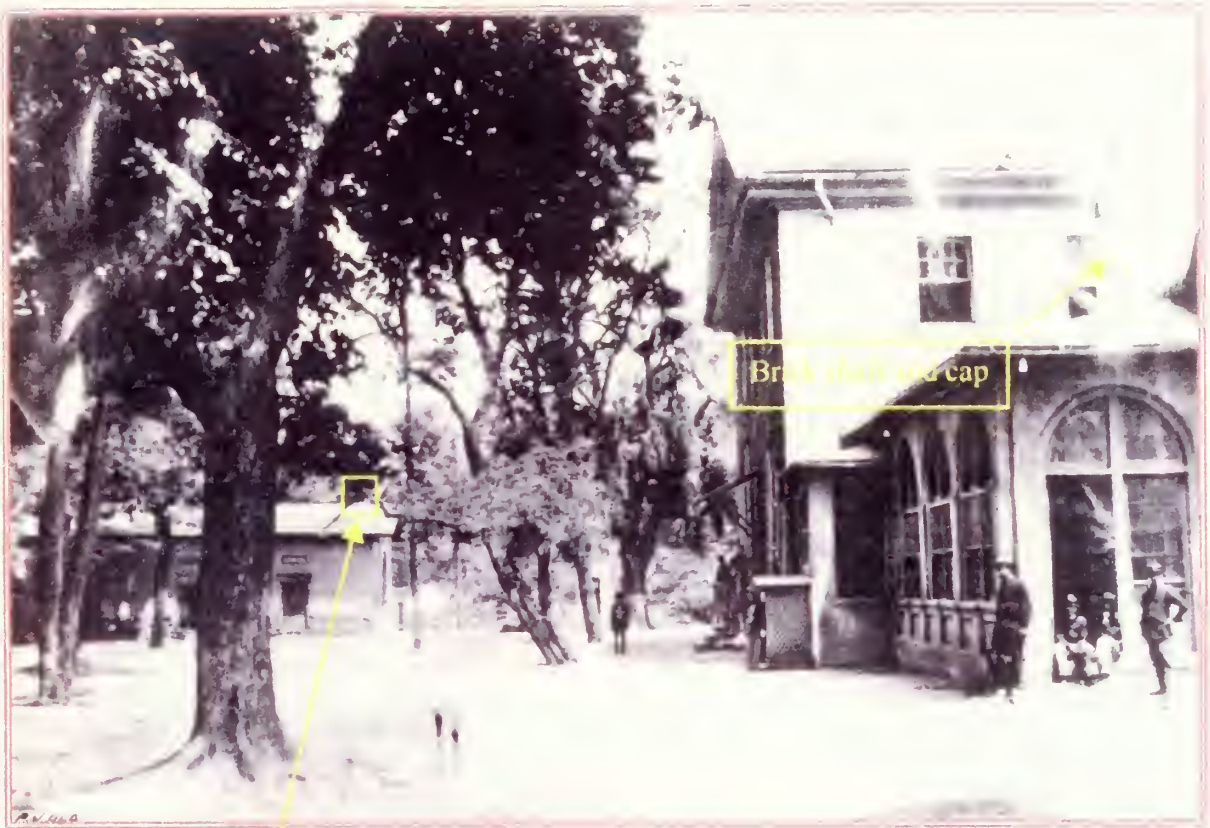
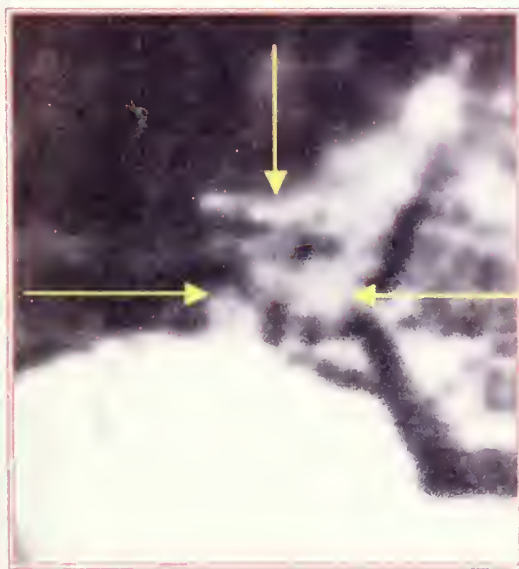
As blurred as it may be, we are looking at a chimney with stucco on the exterior shaft. The large cap modules are cut stone or a fired clay product and were likely stuccoed as well.

Review a clear photo under a 30x loupe lense and you can see the chimney once you find it. It is visible through the tree limbs and leaves.

I am going to say the rise off the peak is about 18"

In my earlier package of information I called the roof extension at 3" and with a loupe lense on a clear photograph you can clearly see the north slope comb at the peak of the roof clearly larger than three inches. I would push the comb out to minimum of 4" and it could go to six inches

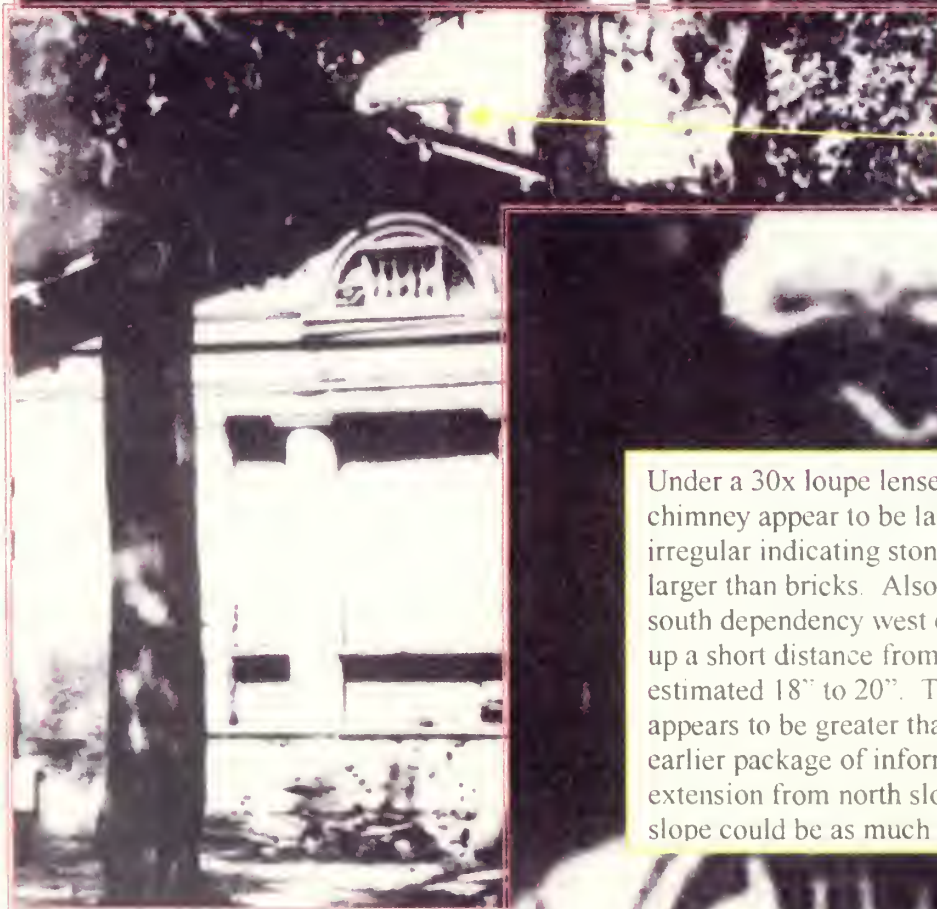
South Dependency Chimney

Under a 30x loupe lense, the modules of the chimney appear to be large and somewhat irregular indicating stone. They are definitely larger than bricks. Also, the chimney is the south dependency west chimney projecting up a short distance from the peak, an estimated 18" to 20". The peak combing appears to be greater than 3" called for in my earlier package of information. The extension from north slope out over south slope could be as much as 4 to 5".

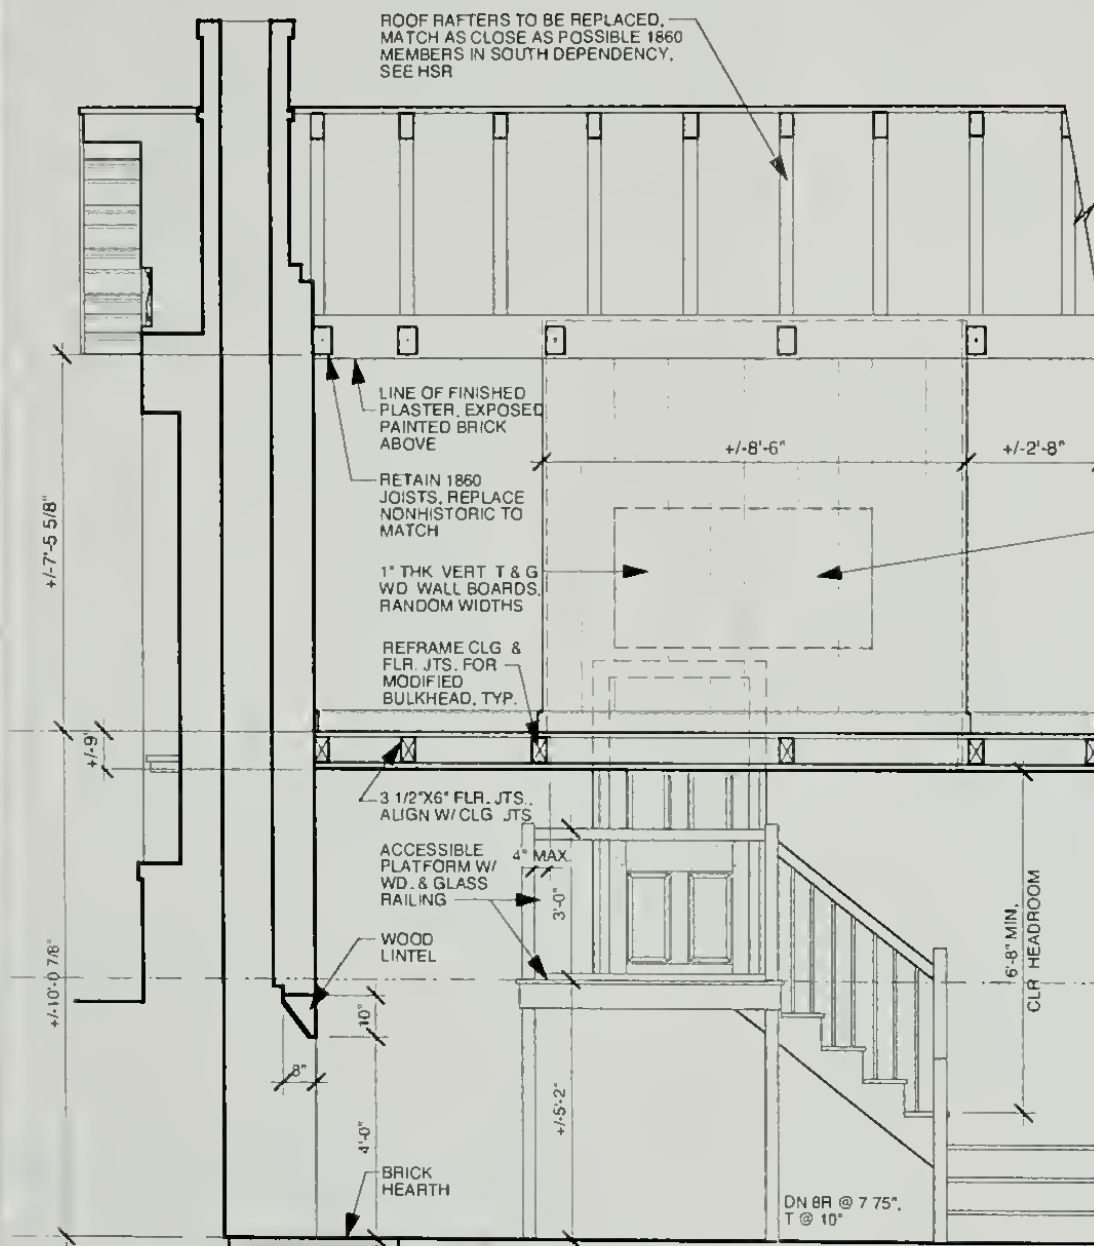
ORIG. UPPER FLOOR  
LEVEL (EL. 108.65' AMSL)

ORIG. BRICK FLOOR  
LEVEL (EL. 98.57' AMSL)

APPROX. LOCATION OF  
VIEWING POINT TO UPPER  
LEVEL FROM ENTRY  
PLATFORM W/  
REMOVABLE WALL  
SECTION

APPROX. LINE  
OF HIST. GRADE  
LEVEL OF GRADE TO ALIGN  
W/ T.O. HIST. THRESHOLD &  
SLOPE AWAY FROM BLDG.  
AS REQD FOR DRAINAGE &  
ACCESSIBILITY
